Here's The Way We Re-set A Taylor Guitar Neck At

The Blue Guitar

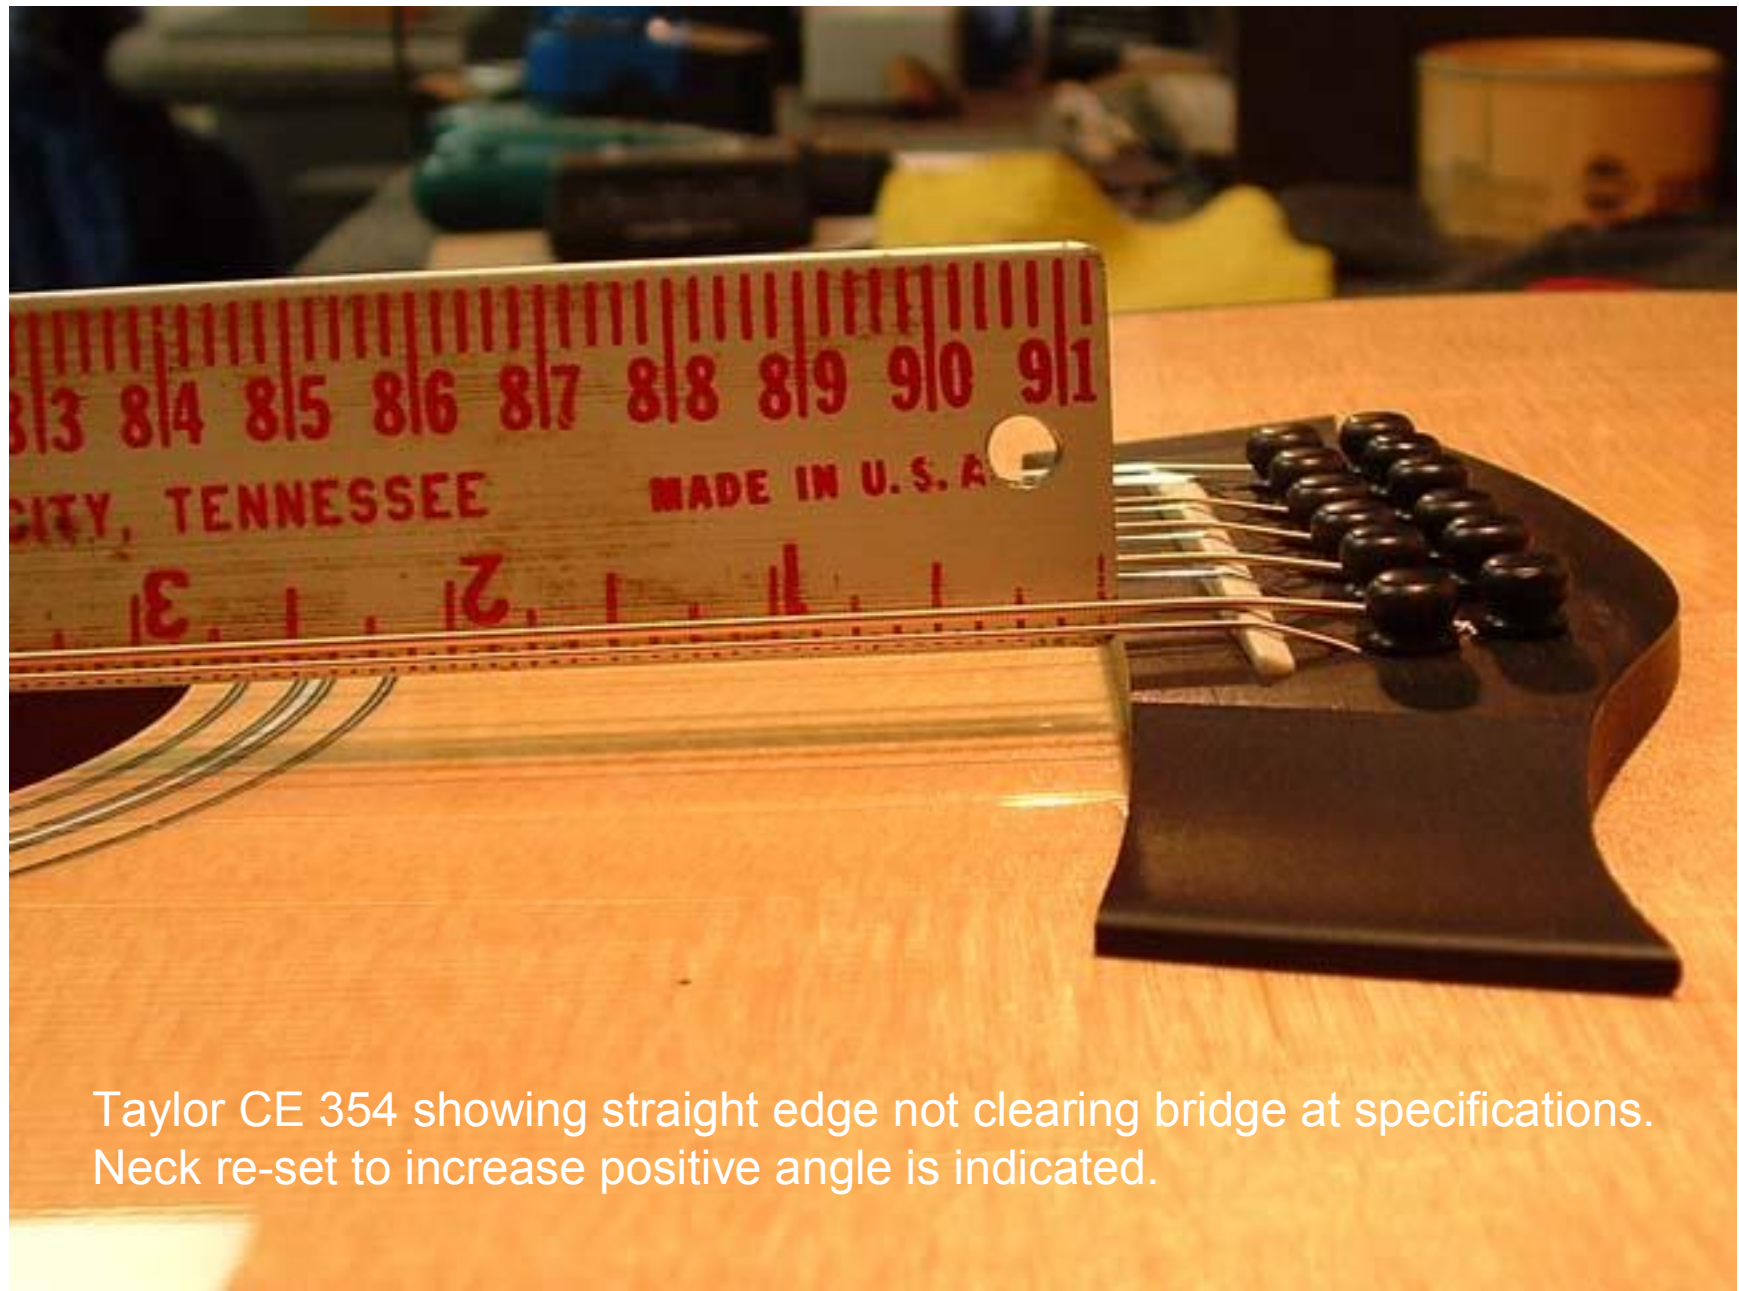
Taylor CE 354 showing straight edge not clearing bridge at specifications. Neck re-set to increase positive angle is indicated.

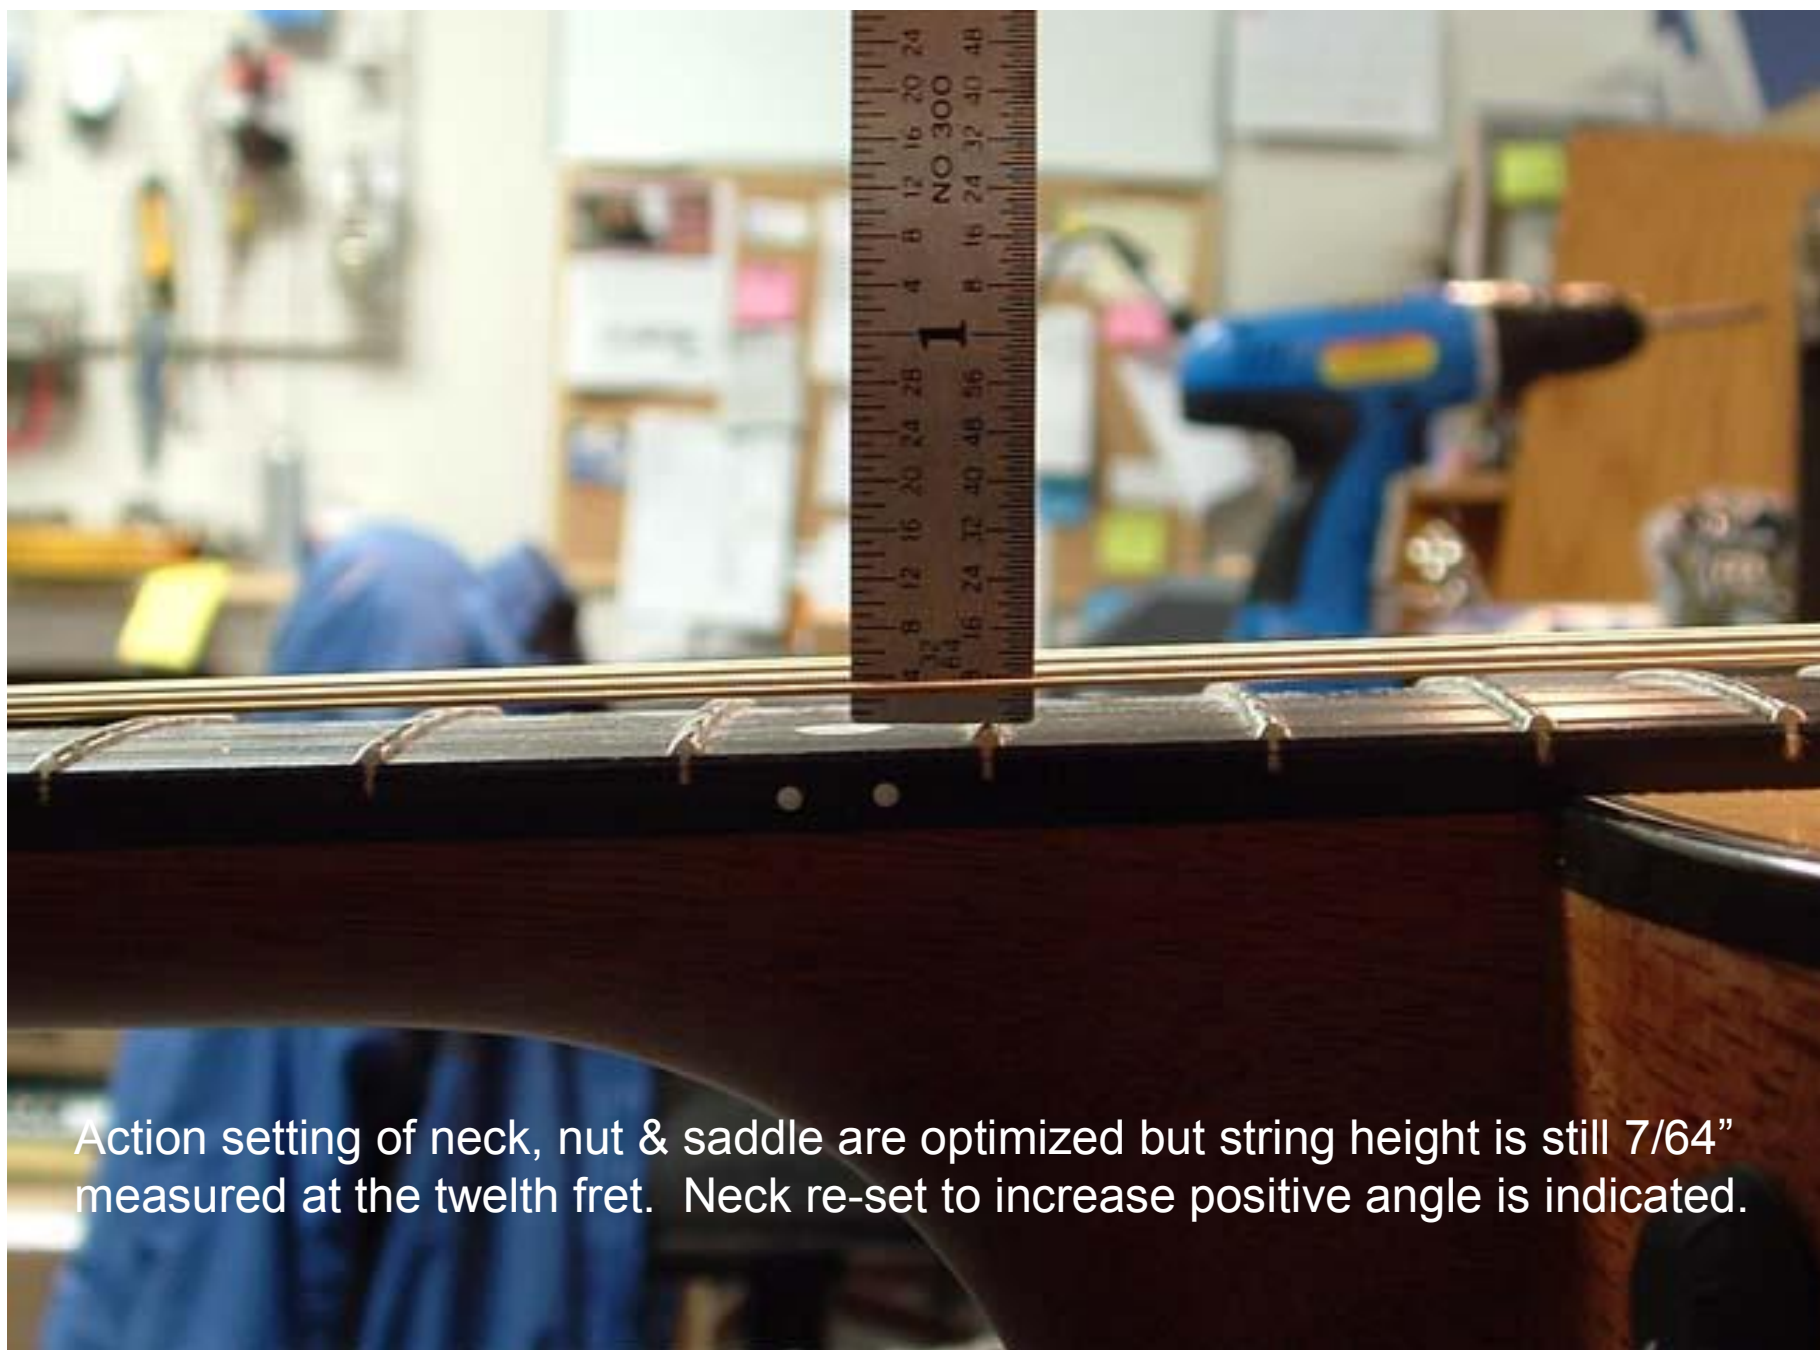
Action setting of neck, nut & saddle are optimized but string height is still $\frac{7}{64}$ " measured at the twelfth fret. Neck re-set to increase positive angle is indicated.

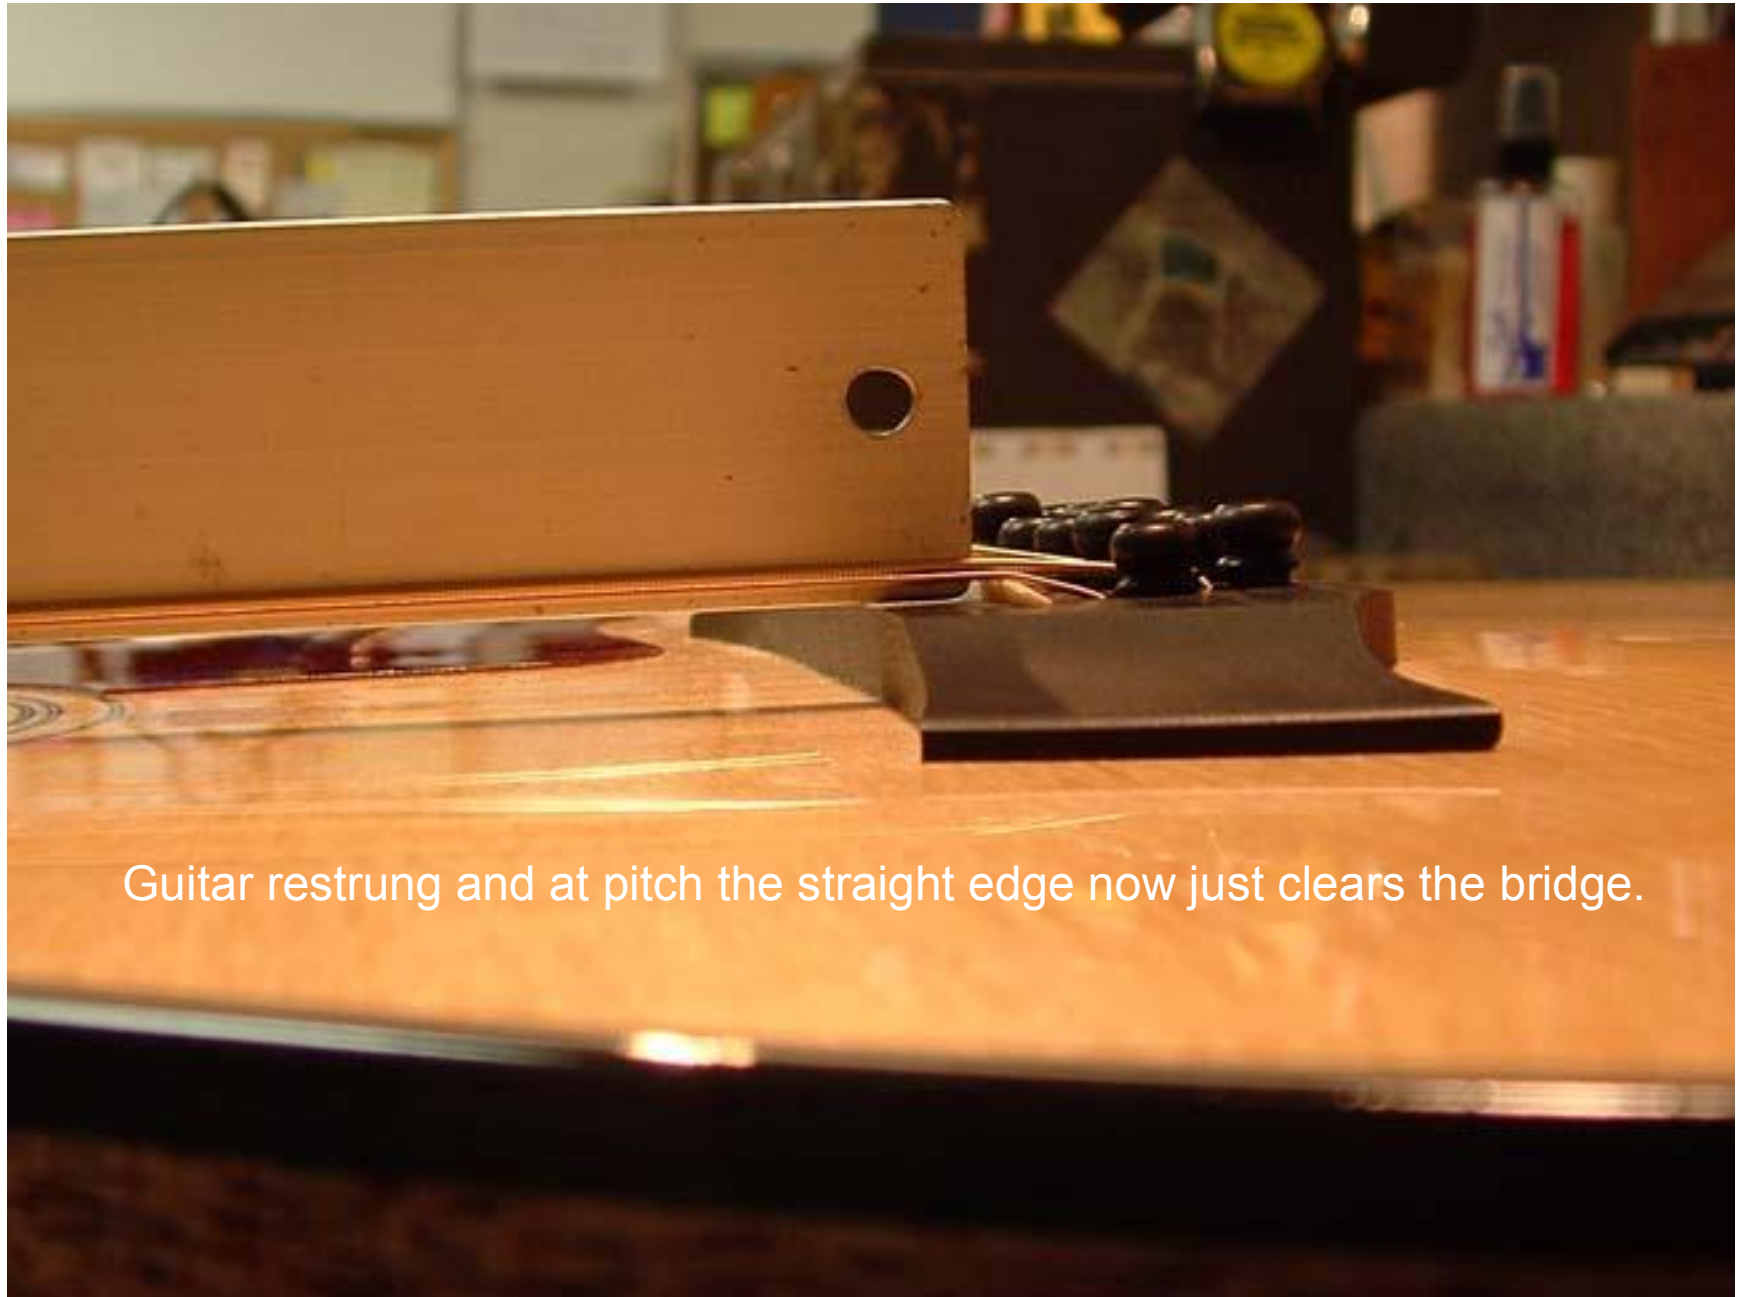
Guitar restrung and at pitch the straight edge now just clears the bridge.

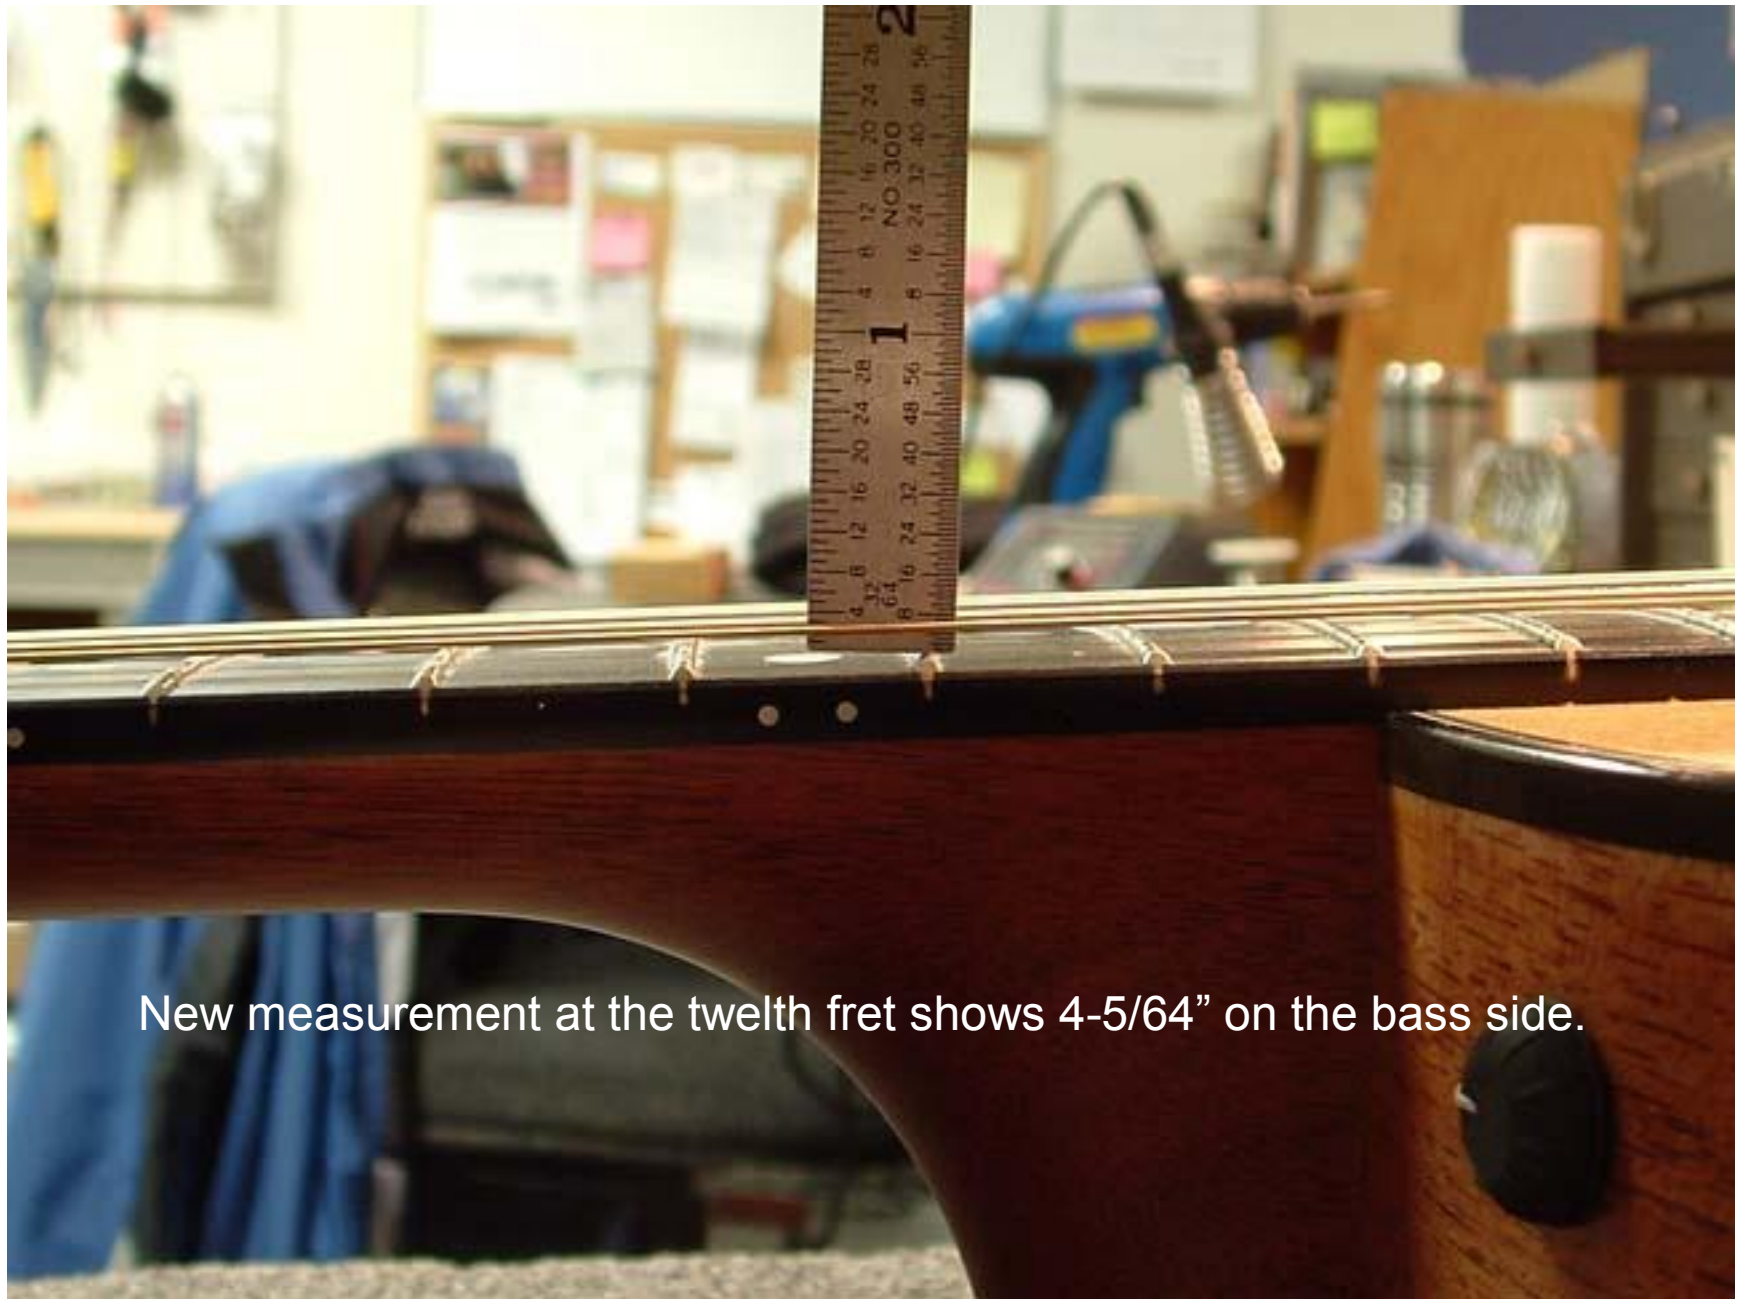
New measurement at the twelfth fret shows $4\frac{5}{64}$ " on the bass side.
