Here's The Way We Re-set A Taylor Guitar Neck At

The Blue Guitar

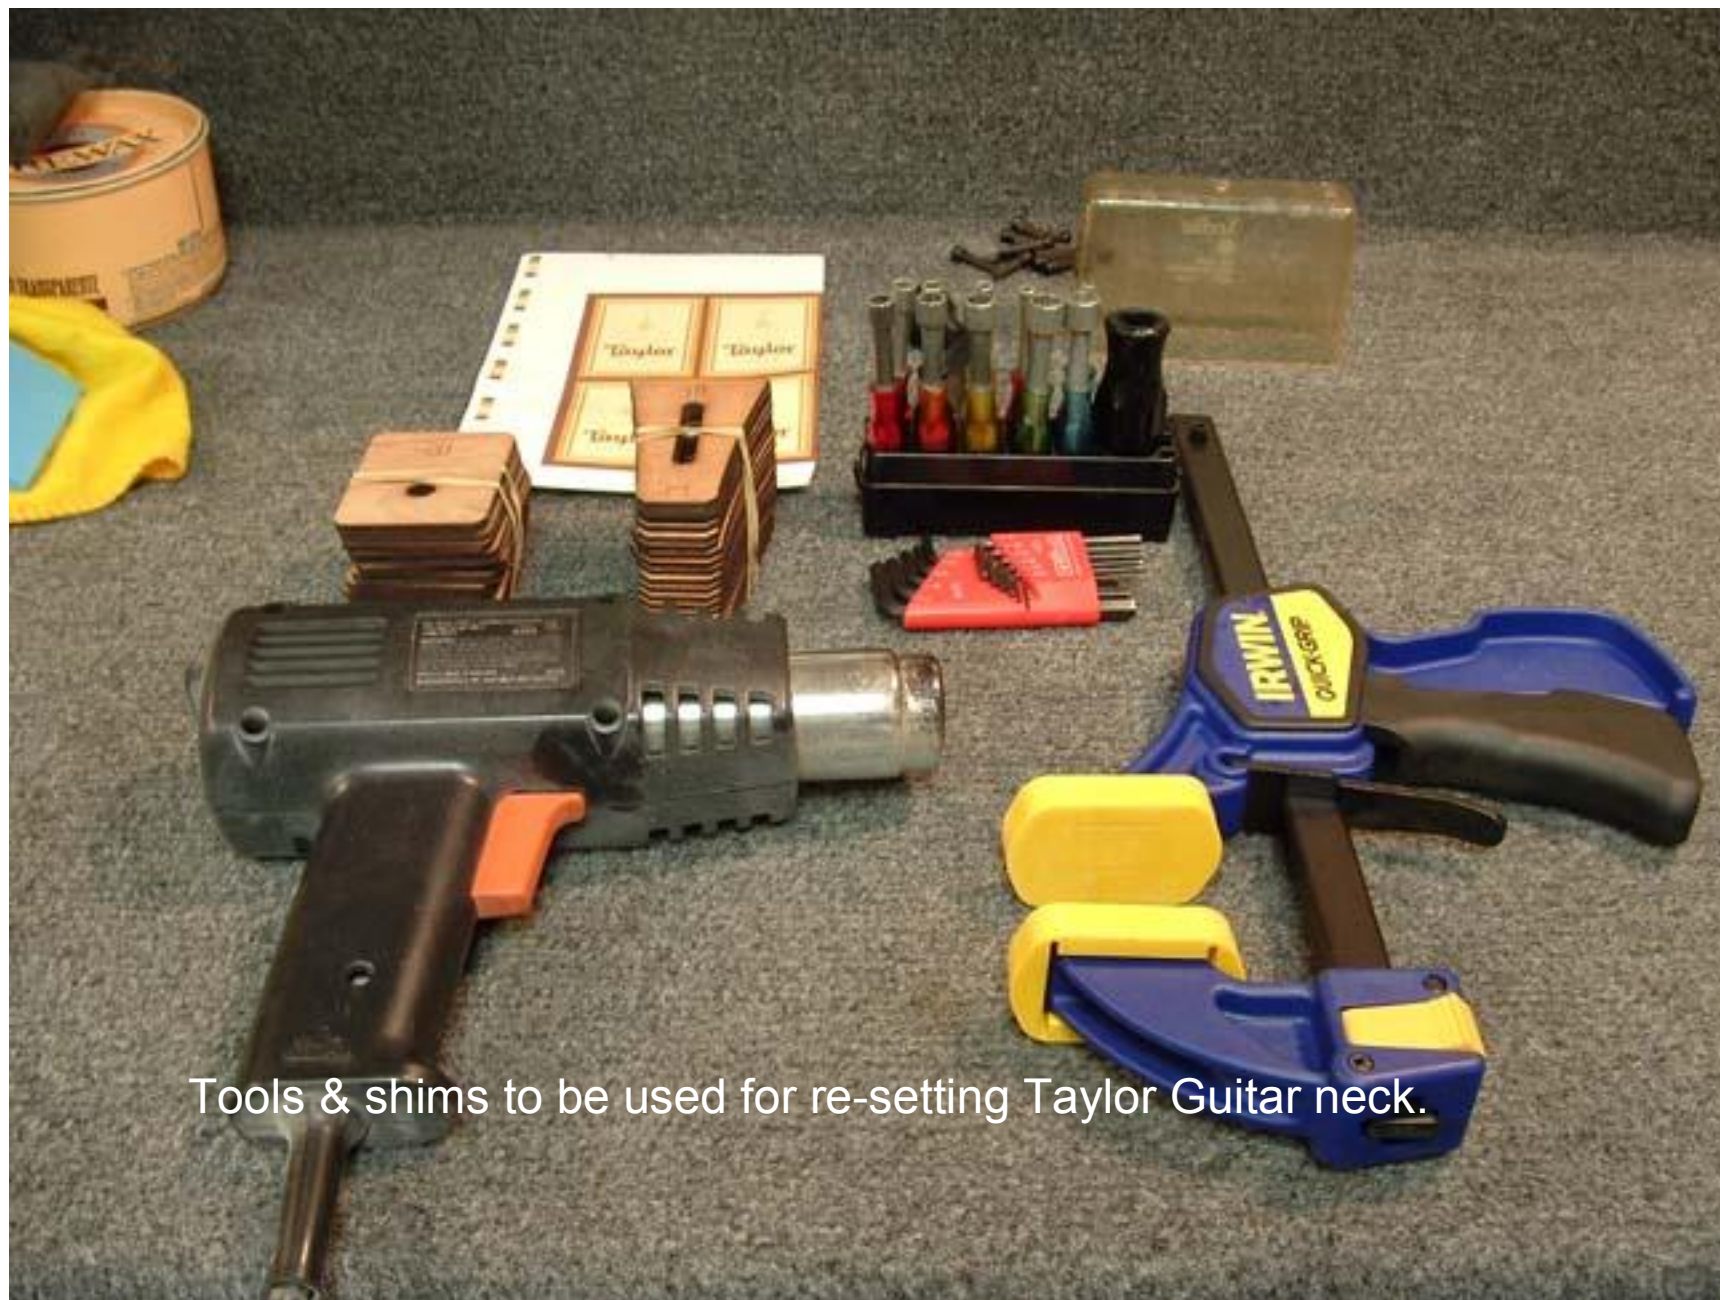
Tools & shims to be used for re-setting Taylor Guitar neck.

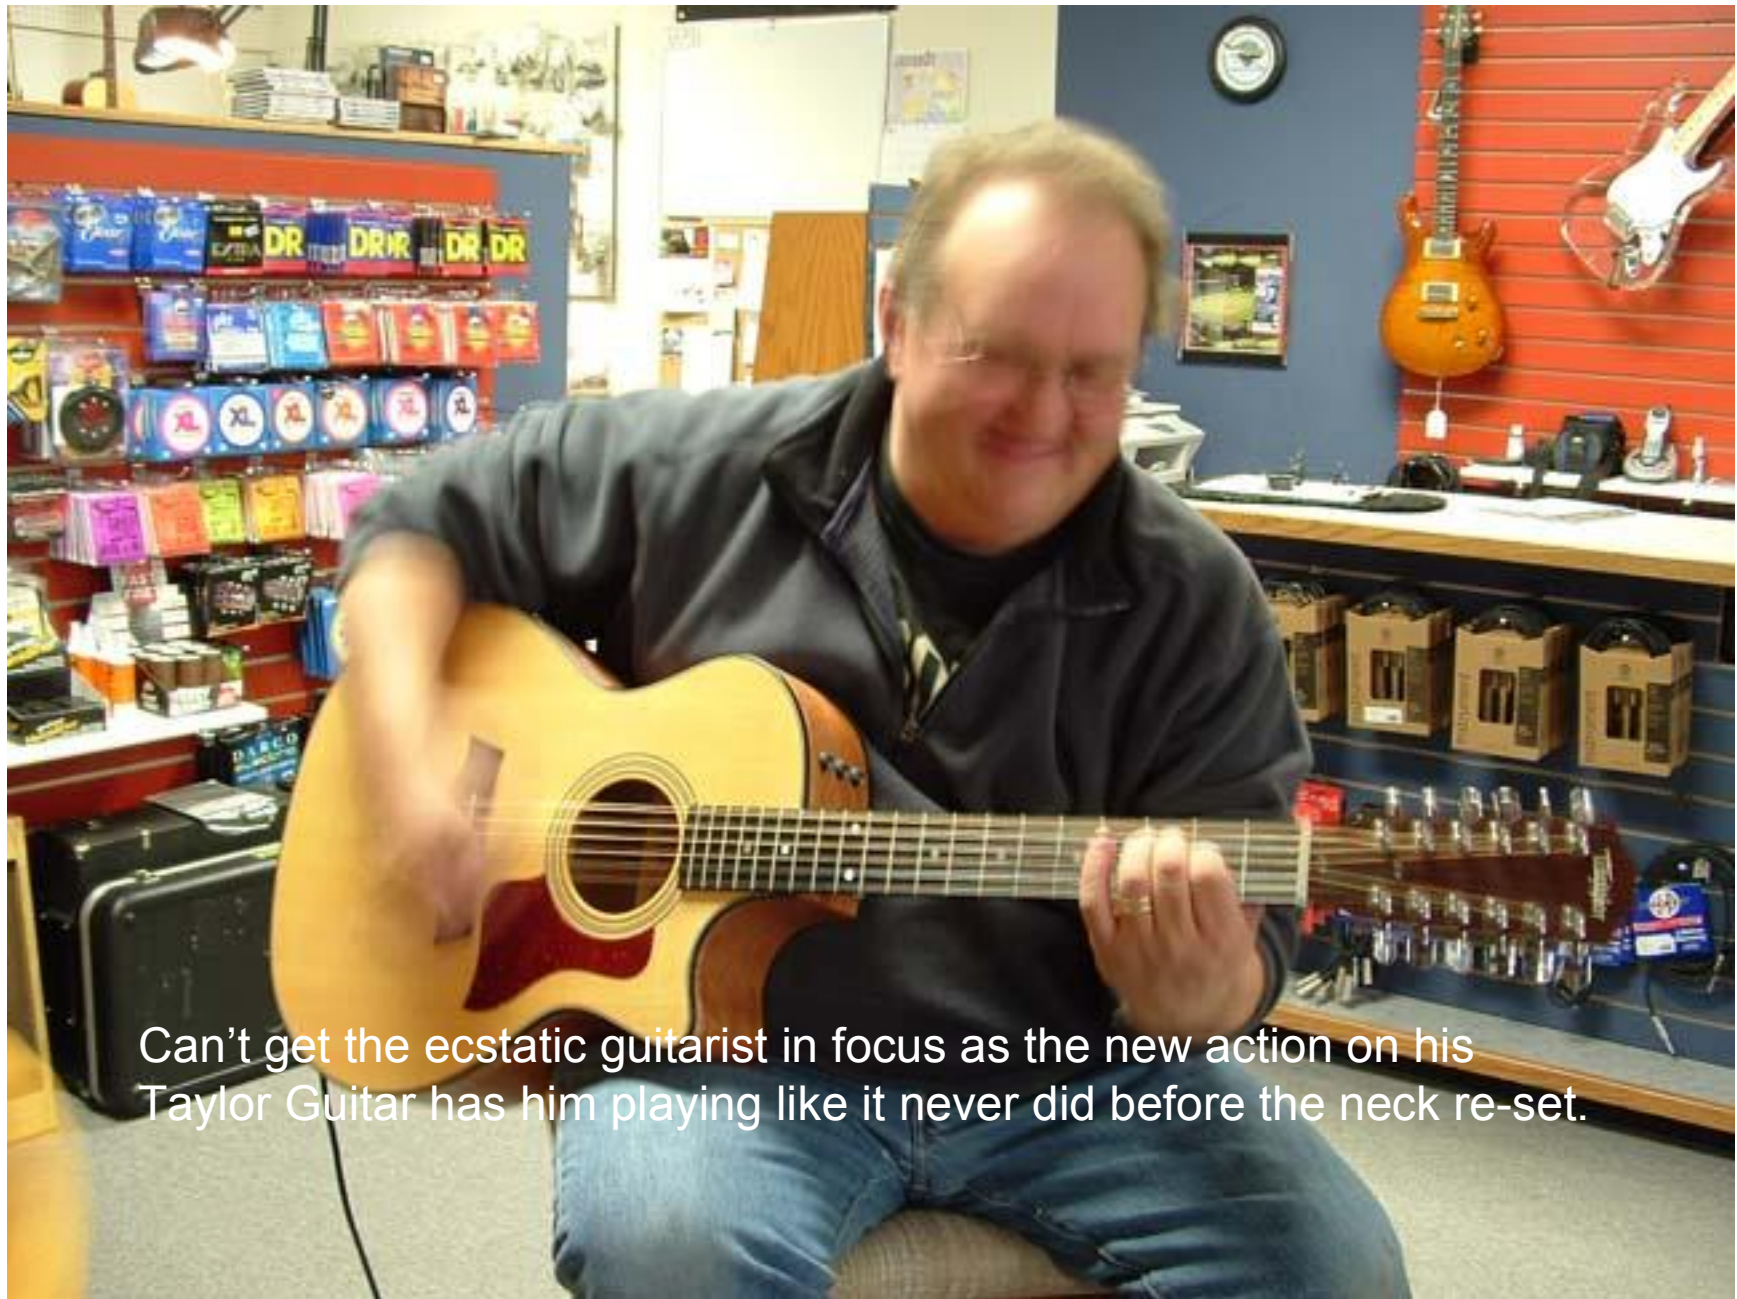
Can't get the ecstatic guitarist in focus as the new action on his Taylor Guitar has him playing like it never did before the neck re-set.
